An Effective Removal System for Zirconia and Lithium-Disilicate Restorations

Proper instrumentation is key to success with today's high-strength ceramics.

By Brent Engelberg, DDS

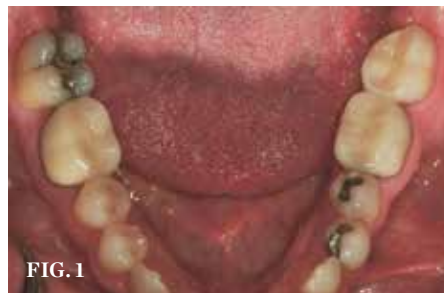
FIG. 1

CLINICAL CASE (1.) The patient presented with a chipped layered zirconia crown on tooth No. 18. **(2.)** The distal-lingual portion of the layered porcelain had sheared away from the underlying zirconia coping.

A 54-year-old man presented with a chipped layered zirconia crown on tooth No. 18 (Figure 1). After only 3 years of service, the distal-lingual portion of the layered porcelain had sheared away from the underlying zirconia coping (Figure 2). It should be noted that this is a relatively common problem with layered zirconia crowns.^{10,11} Consequently, some laboratories advocate the use of full-contour zirconia or lithium-disilicate crowns, which do not have the potential for porcelain shearing.

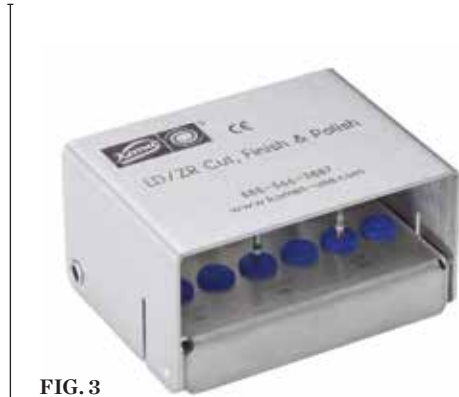
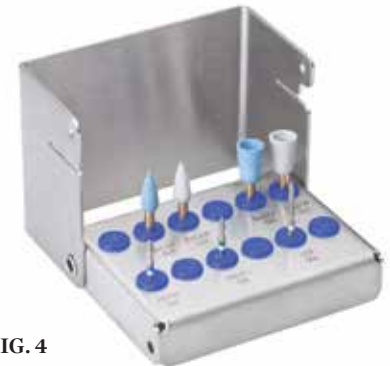
PRECISION-ENGINEERED INSTRUMENTS (3. AND 4.) Komet® ZR™ Cut, Finish & Polish kit.

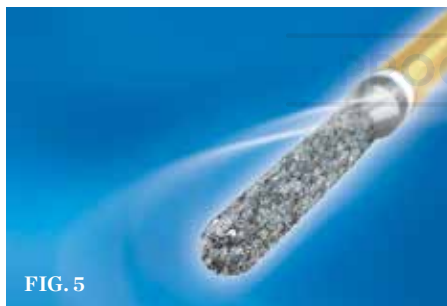
FIG. 5

PREPARATION PROCESS (5.) Komet® 4ZR™ diamond crown cutter. **(6.)** The 4ZR™ diamond bur was used to section the layered porcelain and zirconia coping from lingual to buccal, across the occlusal surface. **(7.)** The crown was sectioned in half, and the two halves were twisted and removed. **(8.)** The crown was removed, resulting in a clean cut.

The patient was anesthetized with one carpule of Septocaine® (Septodont, www.septodontusa.com), and the teeth were isolated (Isolite™, Isolite Systems, www.isolitesystems.com). The fractured layered zirconia crown was removed using the 4ZR™ crown cutter and a high-speed electric handpiece (KaVo, www.kavousa.com).
